Ohio Bureau of Criminal Identification & Investigation INVESTIGATIVE REPORT

12/6/2012 SHOOTING INCIDENT RECONSTRUCTION: CPD CRUISER #238

File Number: CS-18-12-82-1488	File Title: Timothy R. Russell (S) & Malissa A. Williams (S)		
Case Agent: Daniel Winterich	Authoring Agent: Daniel Winterich		
Date of Report: 12/20/12	Exhibit #: 3		
Investigative Activity: Officer Involved Shooting	Supervisor Approval: SAS Dennis Sweet

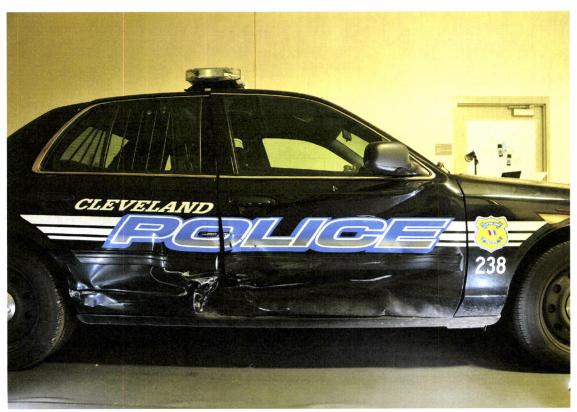
Examination of the exterior revealed body damage to the passenger's side (see Figure 1). Footwear impressions were noted on the driver's side of the trunk, the roof, and the hood. The tread patterns of the impressions from the roof and trunk were similar to each other but different from the patterns on the hood. Two impressions from the trunk (placard A, placard B), one from the roof (placard C), and one from the hood (placard D) were documented via macro photography and then lifted utilizing gelatin lifters.

Figure 1 (damage to passenger's side)

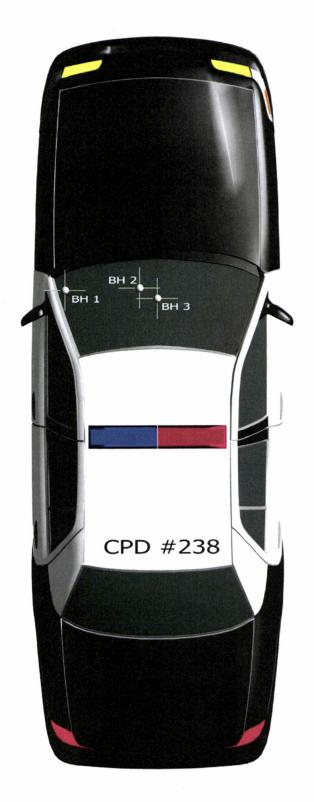
Figure 2 (bullet holes mapped with total station)

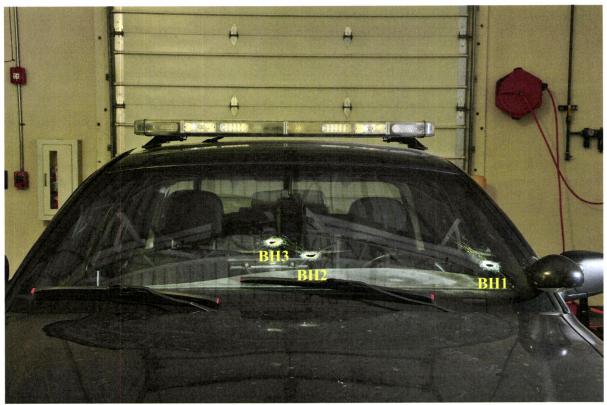
Bullet Hole #	Location	Vertical Impact Angle	Horizontal Impact Angle*	Direction of Travel**
BH1	Driver's side windshield	-24°	15°	Downward, from 9 o'clock to 3, penetrated dashboard into instrument panel.
BH2	Center of windshield	-27°	10°	Downward, from 9 o'clock to 3, penetrated dashboard.
ВН3	Center of windshield	N/A	N/A	9 o'clock to 3.

Figure 3 (BHs 1-3)

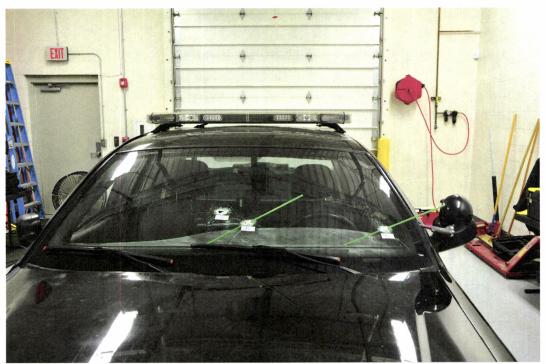
Figure 4 (bullet trajectories)

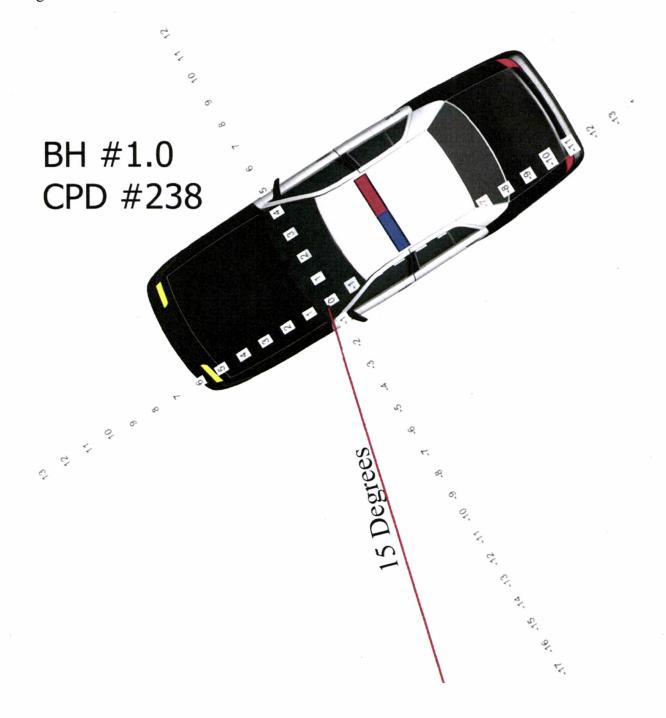
Figure 5 (bullet trajectory for BH1, horizontal impact angle depicted)

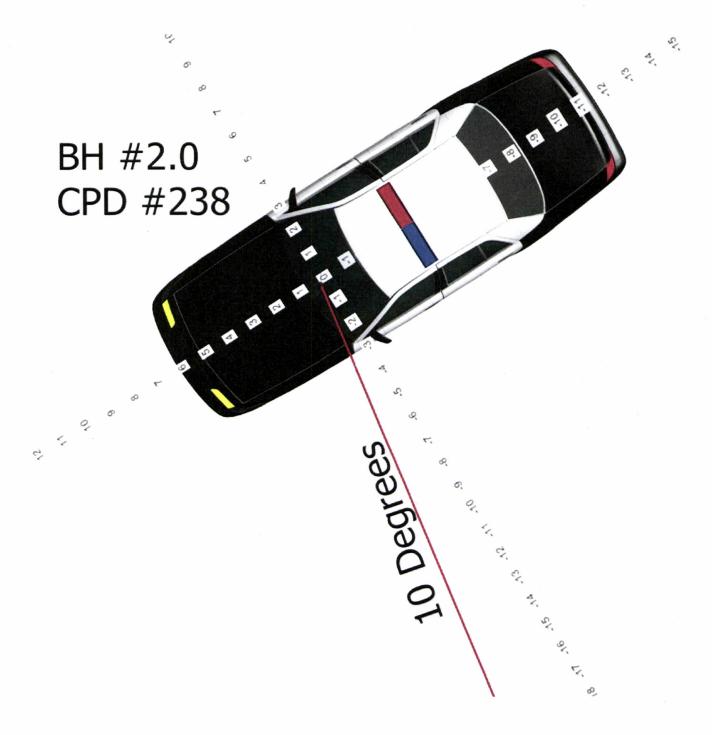
Figure 6 (bullet trajectory for BH2, horizontal impact angle depicted)

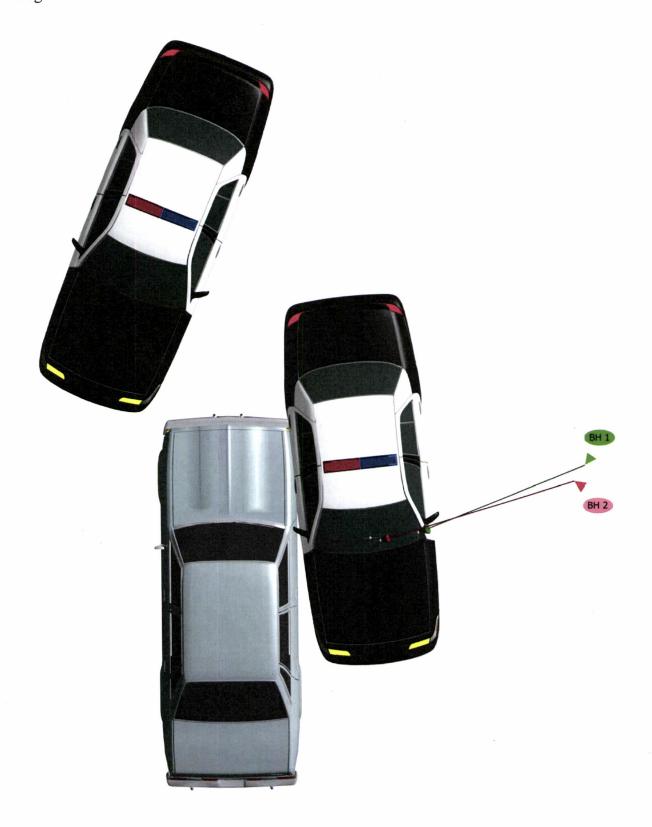
Figure 7 (bullet trajectories with all three vehicles in place)
