2022-1564  
Officer Involved Critical Incident – 1132 Ashwood Drive, South  
Charleston, OH (L)

## INCIDENT REPORT

Incident Type: Fire / Undetermined  
Agency Incident ID: 2022-1437671

Investigation Title: Harmony Estates

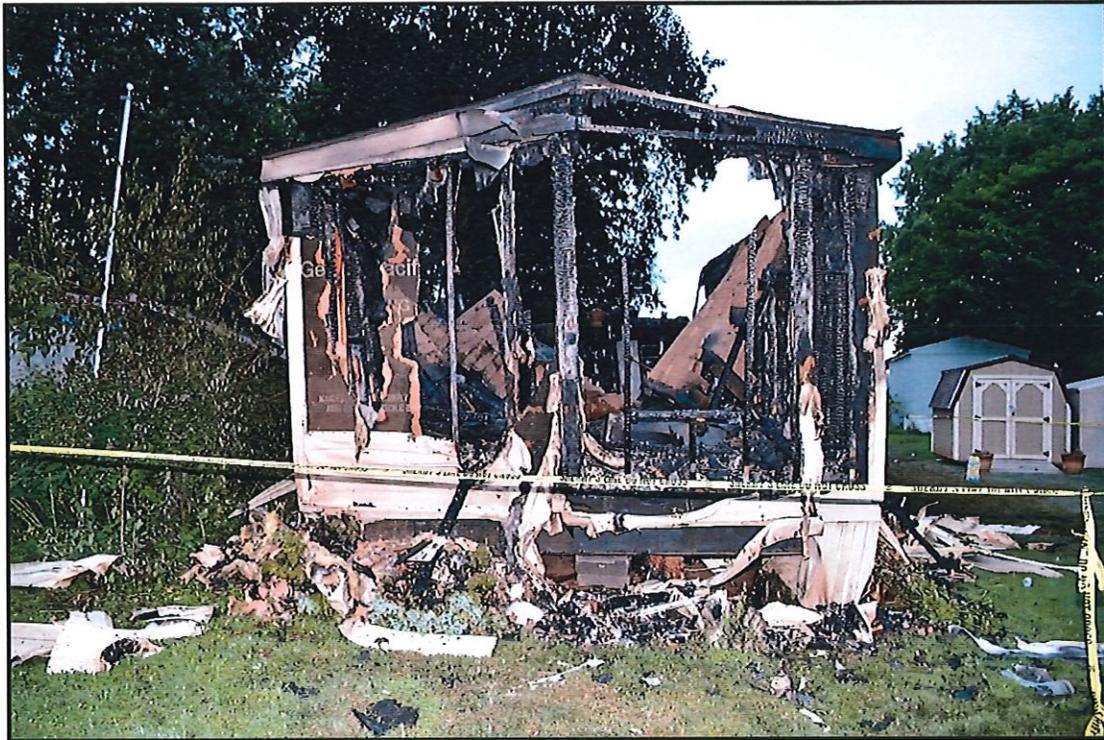
*Figure 1 - Street view of the structure*

The structure was identified as being a 1987 Duke mobile home, approximately 14' by 80'. The unit's identification number is 3AKFB2BALSSR according to the Ohio Title of Certificate. The structure was observed to have its framework elevated and situated on concrete block pylons. The structure being elevated allowed for a sub-structure void space between the framework and the concrete pad.

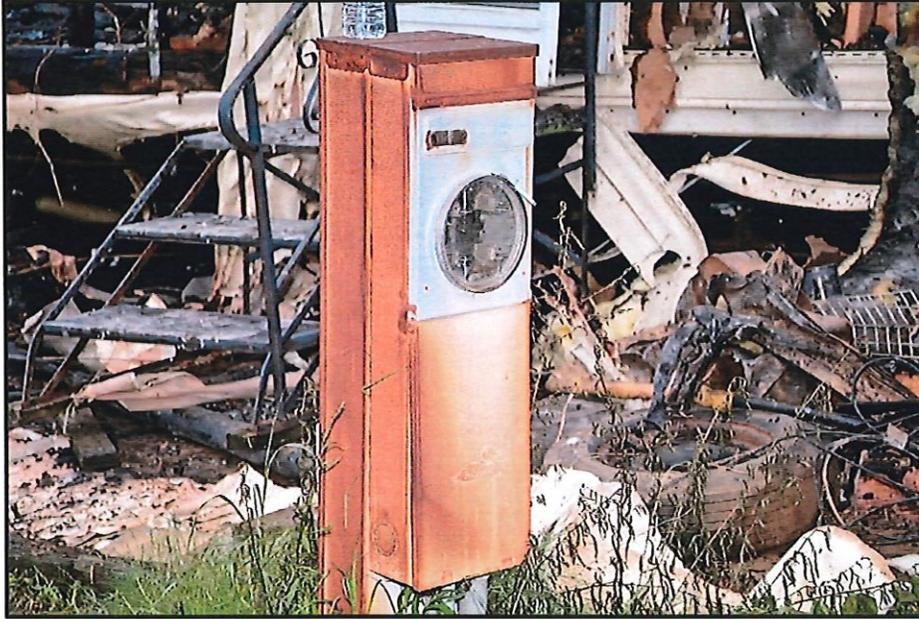
Near the southeast corner of the structure, I observed the electric service for the structure. A metal electric meter/disconnect pedestal was observed with the numerals "1132" affixed to it. The meter had been removed and a plastic plate installed by the utility company prior to my arrival on the scene. Observation of the circuit breakers in the attached disconnect panel showed the presence of a 100-amp Main breaker and a 15-amp branch circuit breaker. Both circuit breakers were found in an "ON" position. The electrical wiring both entering and leaving the pedestal were buried conductors.

*Figure 2 – View of the electric service equipment*

The movement of the structure was observed to have caused the natural gas and electrical service entrances to have stress applied to them. In observation of both service entrances, there was no observable failures which would be considered causal to this fire.

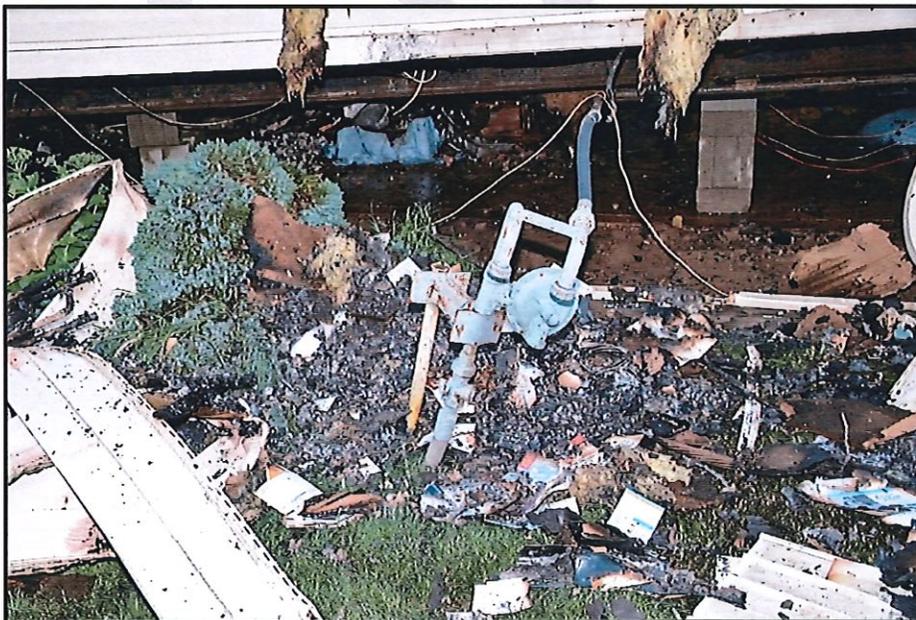
On the south side of the structure, near its west end, I observed the natural gas service supply equipment. This consisted of a supply riser with shut-off valve, piping, and pressure regulator. The supply shut-off valve was found in an “off” position and unlocked. The gas meter had been removed prior to my arrival by the utility provider. Its condition and status are unknown.

*Figure 3 - View of the natural gas service equipment*

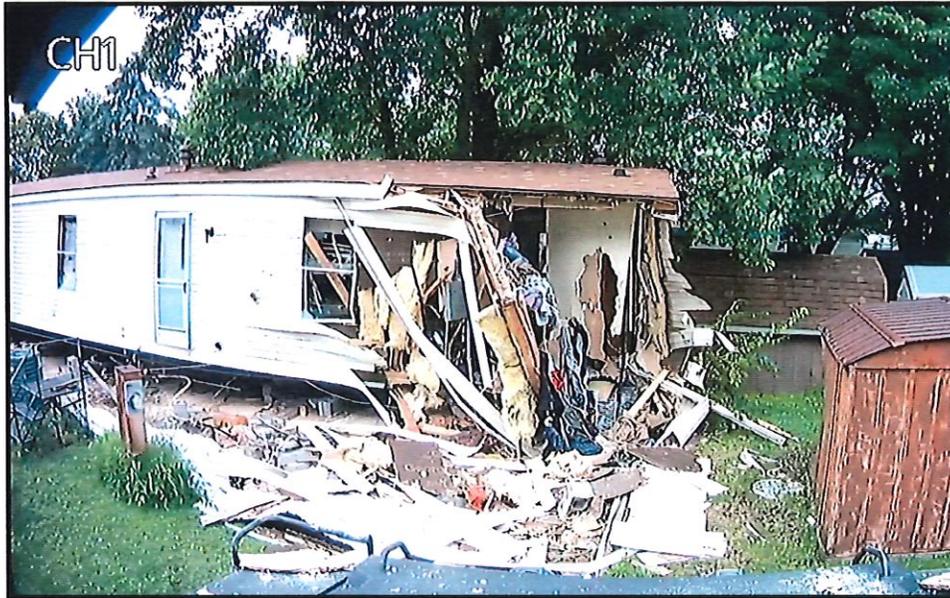
It was observed that the position of the structure’s framework was displaced from its original mounting opposition. The east end of the structure was approximately 10’ north of its original position. The south side of the structure, at its east end, showed evidence of pre-

fire structural damage. This was confirmed as being the result of impacts from the MRAP vehicle during the event.

*Figure 4 – Pre-fire view of structural damage at southeast corner of the structure (MRAP video clip)*

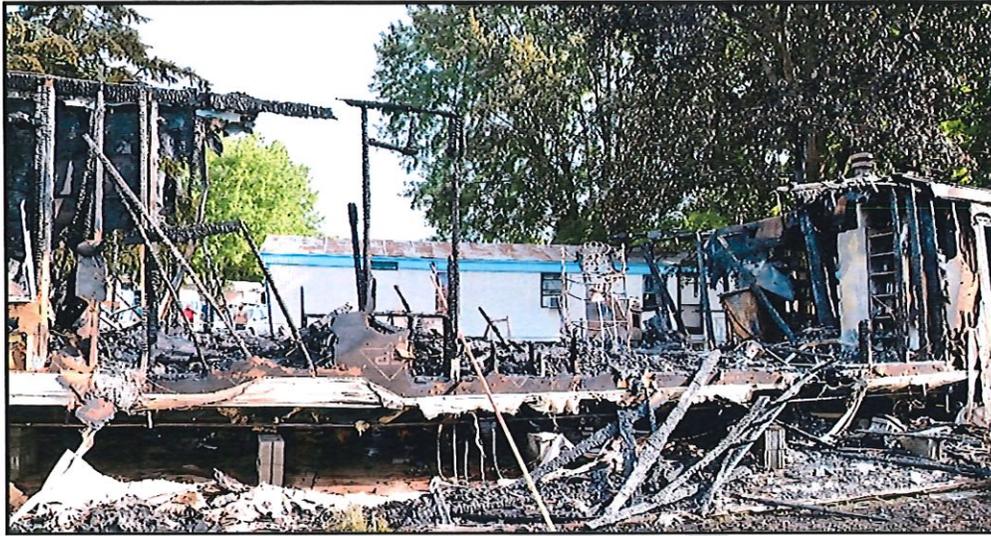
Examination of the sub-structure void space revealed fire debris and damage to be present under the living room and kitchen/dining room areas. Observation and analysis of the fire effects/patterns visible, the damage in this space was considered to be the result of damage as result of fall-down of burning material after the loss of the floor's integrity.

*Figure 5 - View of living room and kitchen/dining room areas from south side of structure*

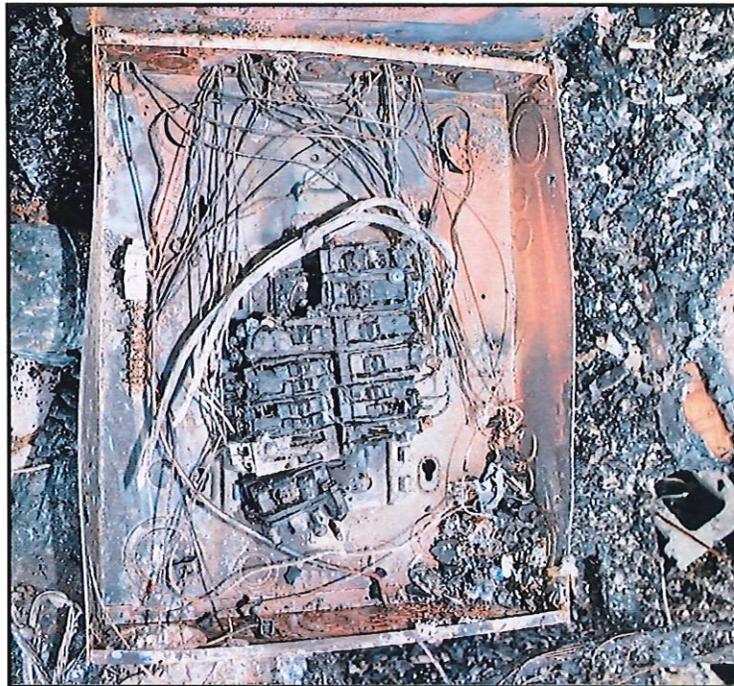
The closet was also observed to contain the main electrical distribution panel for the structure. The panel and circuit breakers within had sustained significant damage during the fire event which hindered the ability to determine their pre- and post-fire condition.

*Figure 6- View of the main electrical distribution panel*
