**Ohio Attorney General's Office  
Bureau of Criminal Investigation  
Investigative Report**

2025-2243

Officer Involved Critical Incident - 3013 Mohawk Street,  
Middletown, Ohio 45044 (L)

**Investigative Activity:** Crime Scene Investigation  
**Involves:** Consuelo Denise Kerr (V)  
**Activity Date:** 07/13/2025  
**Activity Location:** 3013 Mohawk Street, Middletown, Ohio  
**Authoring Agent:** Senior Special David M. Hammond

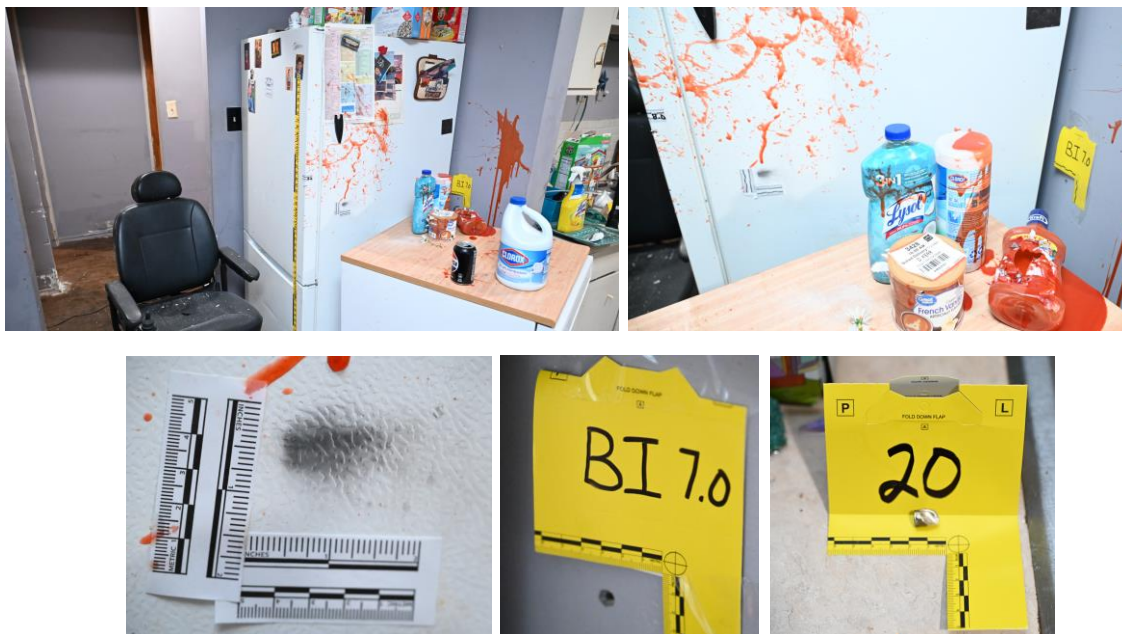
**Reference Photos for BI 7.0 & Fired Bullet**

Further examination of the area located a Ballistic Incident (bullet hole) in the wall that separated the refrigerator area from the countertop. This area was identified with placard BI 7.0. The suspected bullet hole was located approximately 3' above the floor. The suspected bullet hole was symmetrical in shape and measured approximately 10-12mm in width. The margins of the hole were pushed inward, consistent with the projectile originating from a position west of the wall.

It appears that a projectile passed through a can of Great Value French Vanilla coffee creamer and a Kraft French dressing bottle. Areas of orange staining were present on the walls of this area, consistent with the bottle partially dispersing the contents under the pressure of the impact.

Corresponding damage was located on the east side of the same wall. It appears that the projectile perforated the wall, impacting a metal drinking cup and the edge of the counter at the sink. A search of the area located a medium caliber, fired bullet

(jacketed, round nose) on the countertop. It was identified with placard 20 in photographs.

Examination of the evidence at this location of the kitchen suggests that a weapon may have been fired from the location of the refrigerator towards the east, in the general direction of the kitchen sink or rear door. This is based on the position of the wheelchair, location of the Walther handgun, fired cartridge casing, possible gunshot residue, suspected bullet holes and location of the fired bullet. Other possibilities exist.

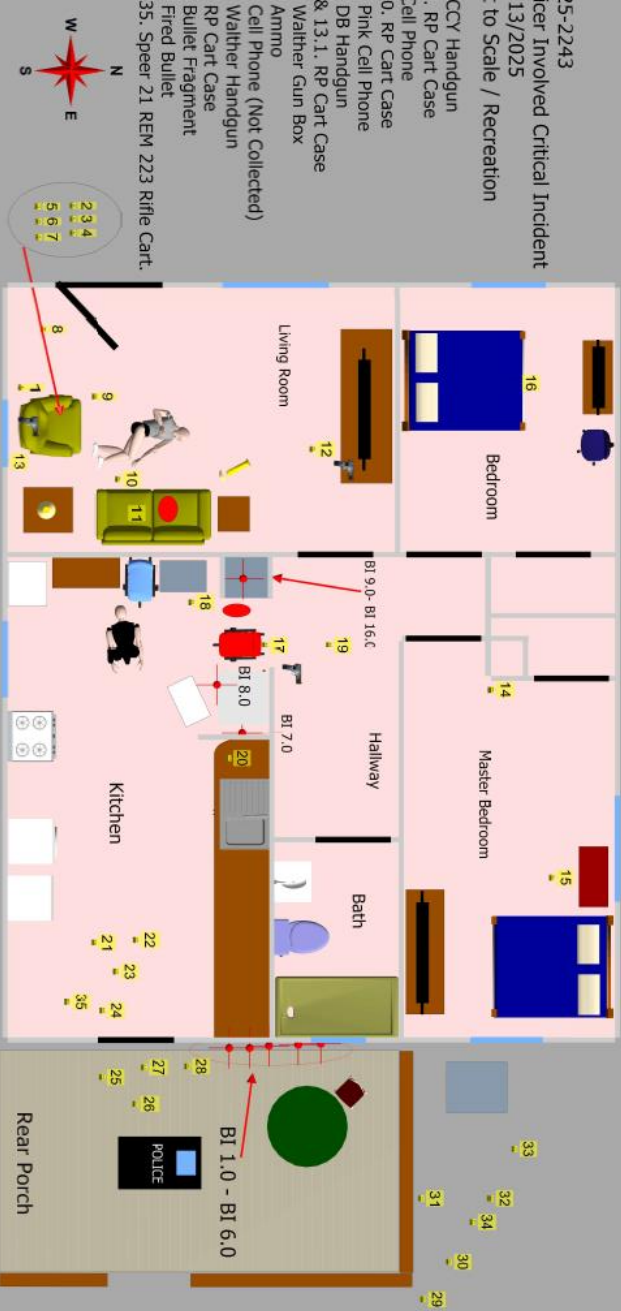
Organization	OHIO BCI	
Drawn By	S/A D. HAMMOND	
Location	3013 Mohawk Street, Middletown	
Date	07/13/2025

<p>2025-2243 Officer Involved Critical Incident 07/13/2025 Not to Scale / Recreation</p> <p>1. SCCY Handgun 2-6. RP Cart Case 7. Cell Phone 8-10. RP Cart Case 11. Pink Cell Phone 12. DB Handgun 13 &amp; 13.1. RP Cart Case 14. Walther Gun Box 15. Ammo 16. Cell Phone (Not Collected) 17. Walther Handgun 18. RP Cart Case 19. Bullet Fragment 20. Fired Bullet 21-35. Speer 21 REM 223 Rifle Cart.</p>
