2022-1564  
Officer Involved Critical Incident – 1132 Ashwood Drive, South  
Charleston, OH (L)

## INCIDENT REPORT

Incident Type: Fire / Undetermined  
Agency Incident ID: 2022-1437671

Investigation Title: Harmony Estates

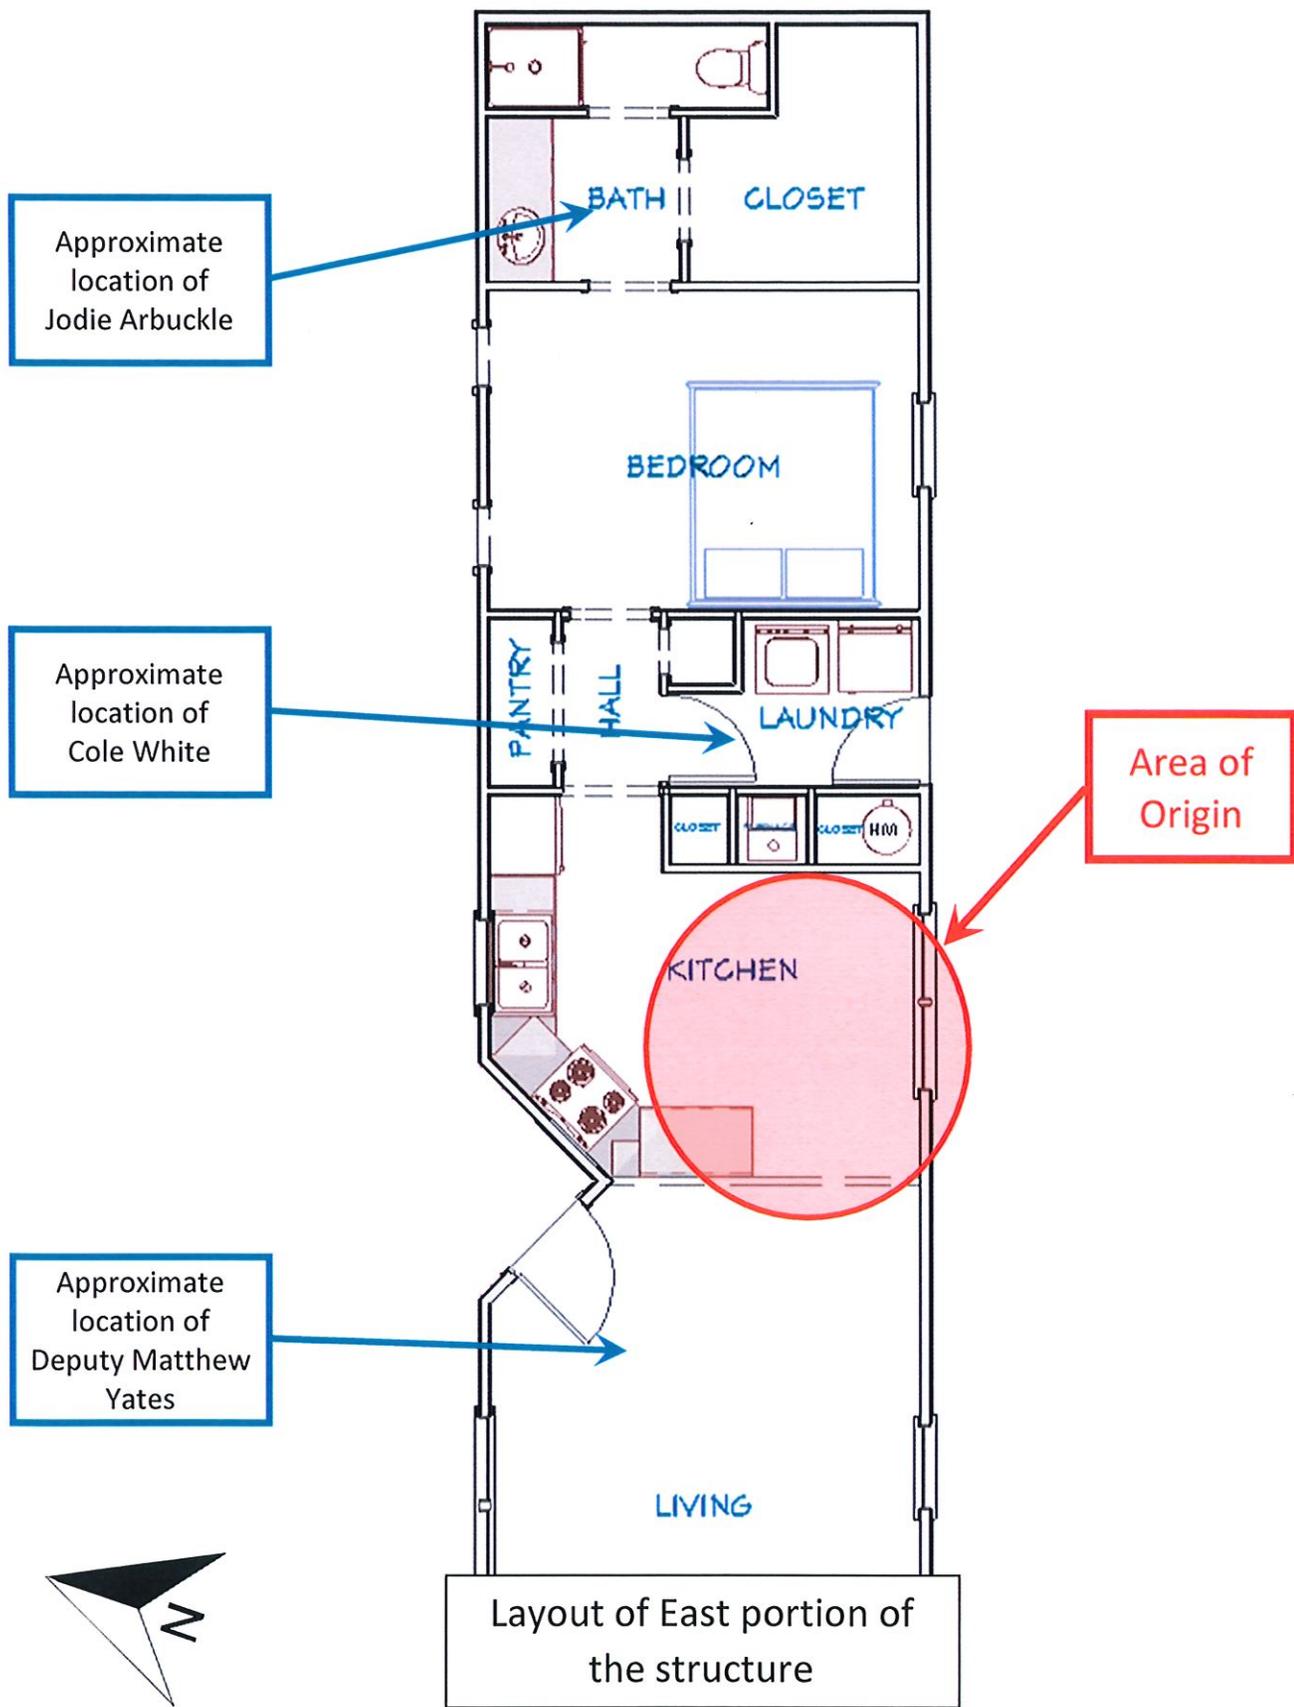
<p>Division of State Fire Marshal          Fire and Explosion          Investigation Bureau</p>	<p>Address: 1132 Ashwood Drive, South Charleston, Ohio          County: Clark          Owner: White, Cole</p>		
<p>2022-1437671</p>	<p>Investigator: T. Schreadley</p>	<p>Date of Incident: 07/24/2022</p>	<p><b>*NOT TO SCALE*</b></p>
